CASE STUDY 5

IZAAK WALTON GOLF COURSE

FARMING FLOODPLAINS for the FUTURE

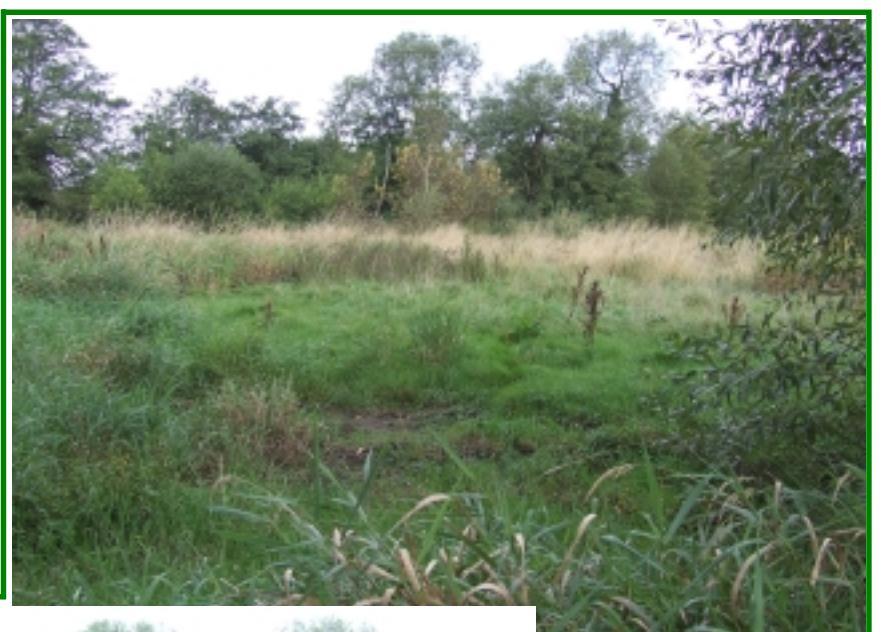
Existing on-line pond

- 4 The on-line ponds in the tributary stream have sufficient freeboard to allow storage of additional water. The outflows for the two largest ponds each comprise three 300mm diameter pipes. Under 'normal' flow conditions, the pre-existing pond water level is now maintained by a single pipe. The other two pipes have been altered, fitted with 90° bends (and on the downstream pond, where freeboard is greater, additional risers) such that once the capacity of the single pipe is exceeded, water is backed-up and stored in the pond upto the level of these other pipes, which then carry excess flow downstream. The storage capacity of both ponds has been enhanced with the construction of shallow bunds around their downstream ends. Depths of additional storage is 0.52m (upstream pond) and 0.8m (downstream pond), equating to volumes of 365m³ and 930m³ respectively.

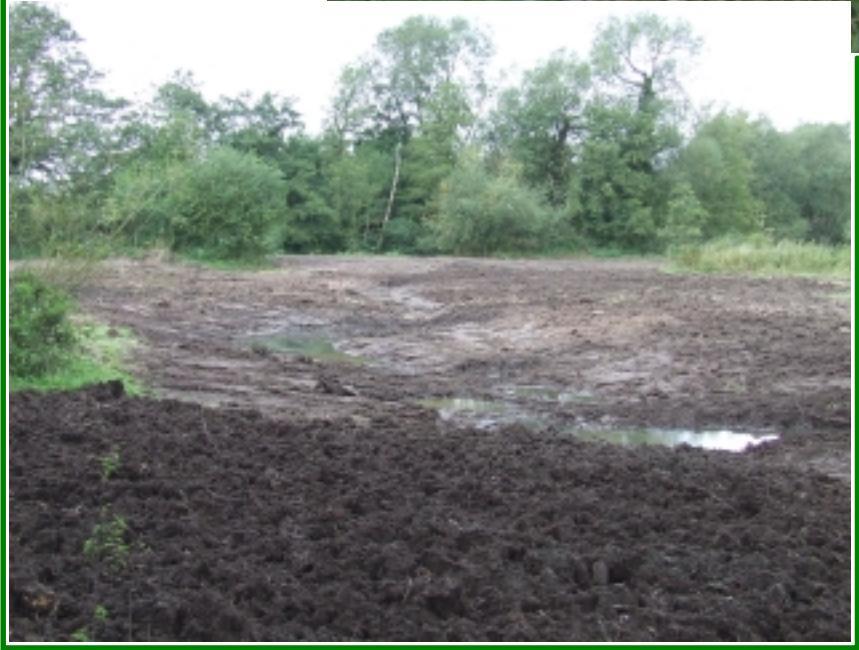
Floodplain restoration, before and after works

- 2 Historically mounds of earth, tree stumps and other materials had been dumped within the floodplain of the Meece Brook. Covering an area of approximately 750m², and upto 1 metre in height, this material was removed from the floodplain (and deposited in a large hollow elsewhere on the course). The area has thus been restored to 'natural' ground level, increasing floodplain capacity and promoting flood flows away from the fairway.

- 3 Existing low spots were accentuated to create 0.13ha of permanent wetland habitat within the floodplain, comprising two small, linked pools, with adjacent areas profiled to allow natural regeneration of associated marginal habitats.

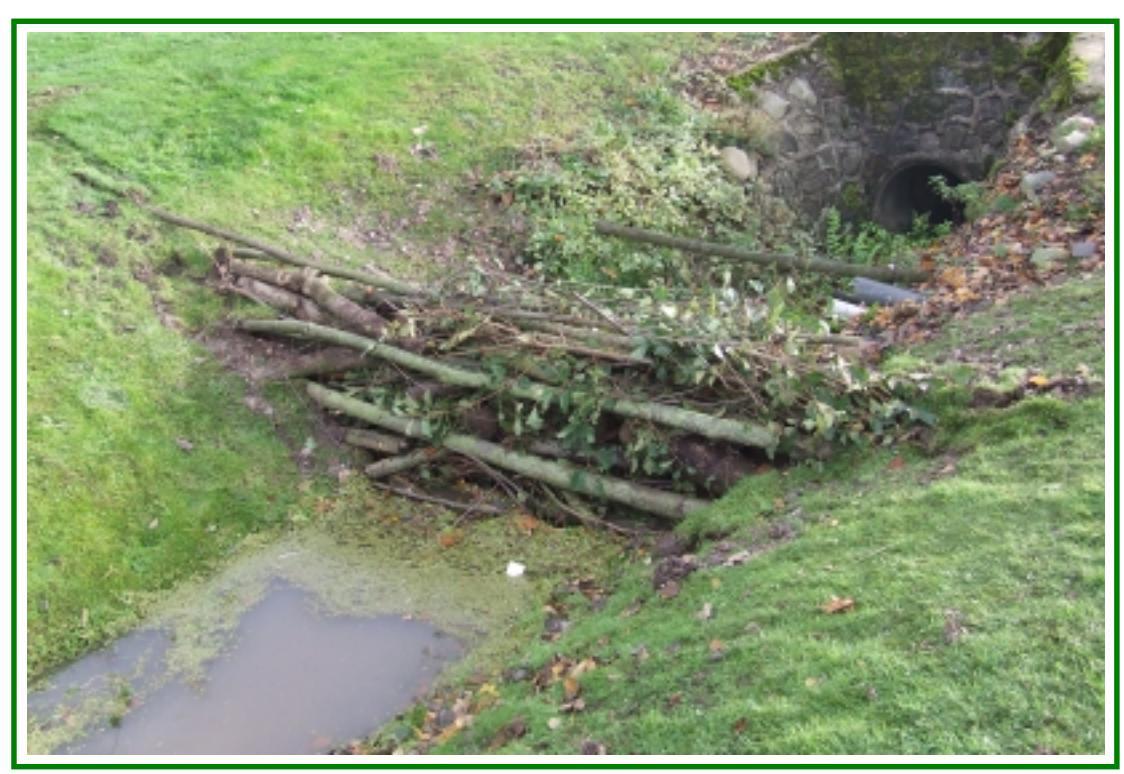
Debris dam

- 6 Upstream of the ponds, the tributary stream flows in a deep, steep-sided channel. To increase use of the channel's capacity, debris dams have been installed in two locations. These comprise small logs and large branches (sourced from a local contractor) stacked in the channel (and dug into the banks to secure them) to form 'leaky barriers' upto 0.75 metres in height. While allowing flows to pass through them, the structures will restrict peak flows resulting in backing-up and temporary water storage. Care had to be exercised in locating the upstream dam to avoid potential adverse impact on a neighbouring landowner.

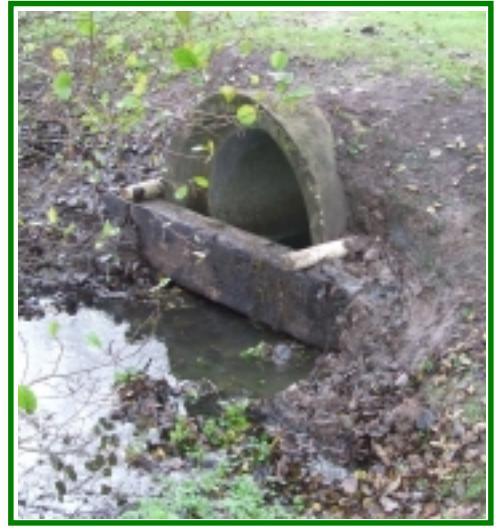
Third altered pond outflow

- 5 The third on-line pond outflows through a 1metre diameter concrete culvert. To take advantage of potential storage, a section of railway sleeper was secured in the entrance of the culvert, set at a level to allow 'normal' flows to pass beneath. Once this space is exceeded water backs-up in the pond to the depth of the sleeper, before this is over-topped and water continues to flow downstream through the culvert.

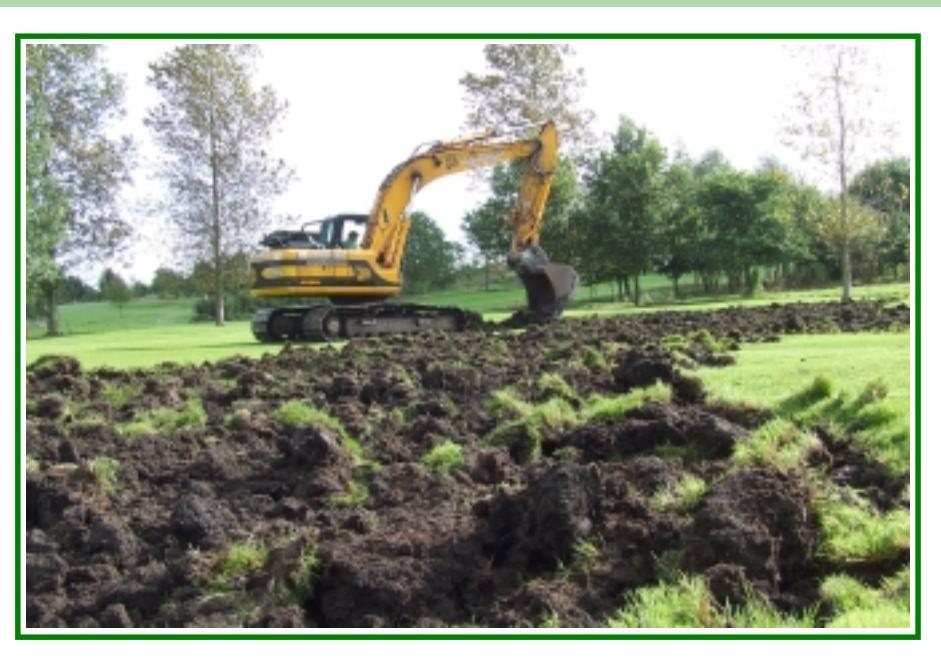
Re-profiling of fairway in progress

- 1 The worst affected area of the fairway (approximately 0.2ha) was re-profiled to promote surface water run-off into the 'rough' occurring within a meander of the Meece Brook. [The golf club organised for this area to be cultivated and re-seeded.]
