# Project Case Study

## Trent Valley - Rural SUDS - Mottey Meadows

**Rural Sustainable Drainage Systems (RSuDS) to help reduce the amount of diffuse pollution entering Mottey Meadows Special Area of Conservation (SAC).**

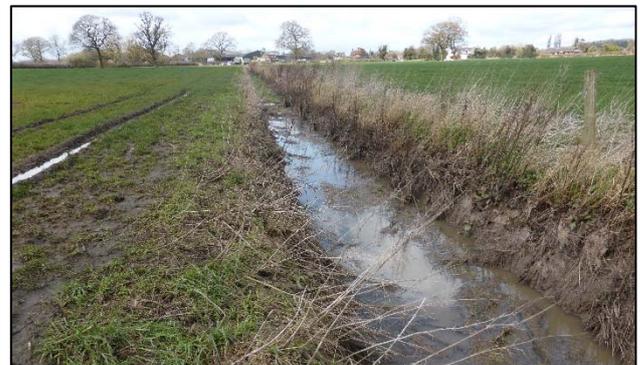
**Before (April 2016)**

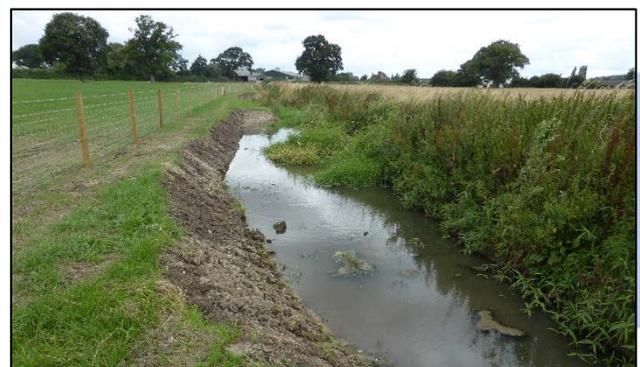
A series of reedbeds have been created along a ditch that carries dirty water from the farm to the Motty Meadows Brook. Each reedbed will allow for sediment settlement, water treatment and holding back a limited amount of water, before flowing into the brook. The reedbeds have wetland vegetation including reed sweet-grass and bulrush growing within them, which will aid the treatment of surface water and farm yard run-off by enhancing sediment removal. This will help to improve the water quality and buffer the SAC.

**After (August 2016): A series of reedbeds.**

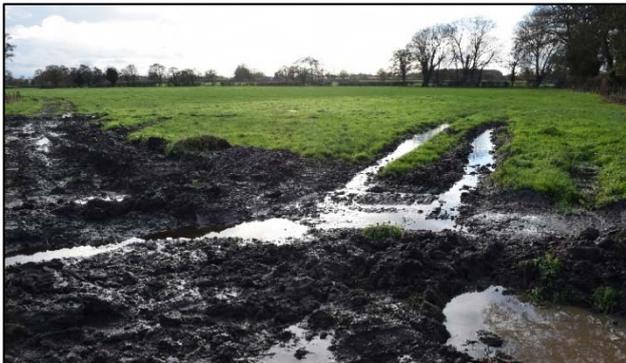
Before (November 2015)

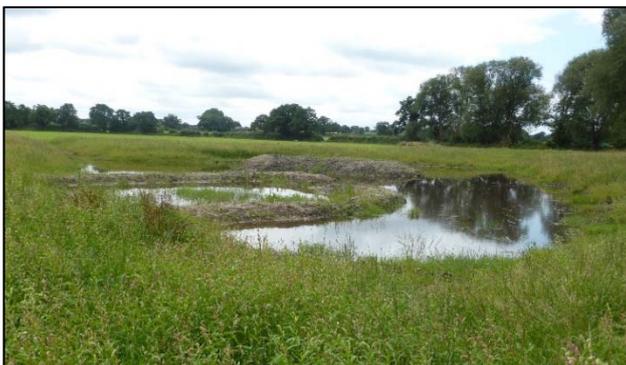
A large wetland pond has been created, situated in a field to the south of the farm, adjacent to a tributary of the Motty Meadows Brook. The pond was contoured so that it has an average depth of 1 m, however there are deeper and shallower areas which will be beneficial for freshwater wildlife. The pond water flows into a small area of reedbed so that it is treated before it is piped under the existing track into the un-named tributary. The reedbed has been planted up with iris to aid the treatment of surface water run-off by enhancing sediment removal.

After (July 2016): Wetland pond with reedbed.

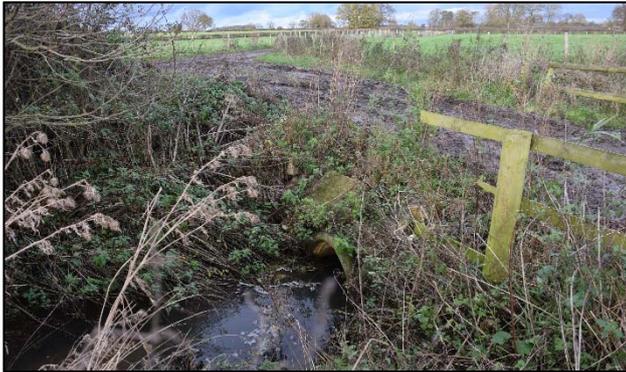
Before (November 2015)

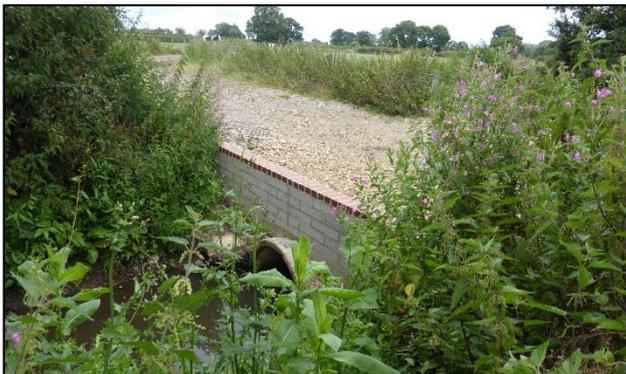
After (August 2016): Motty Meadows Brook and track.

At the junction where the tributary meets the Motty Meadows Brook, we have upgraded the pipework, track and headwalls to allow better access for cattle and machinery to other areas of the farm. Additionally, we have relocated the cattle drinking trough from an area adjacent to the Motty Meadows Brook, to the other side of the field in order to reduce cattle poaching around the brook. (Please see additional photos in the Appendix).

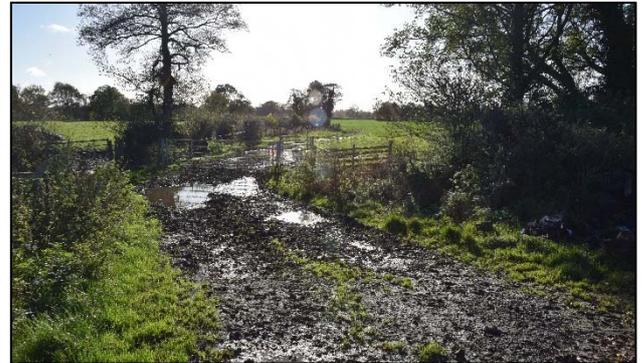
Before (November 2015)

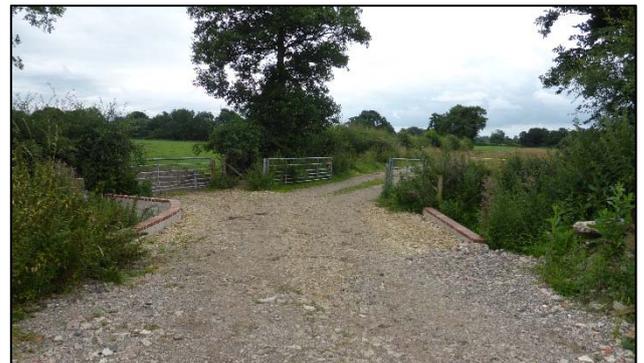
After (August 2016): Trackway.

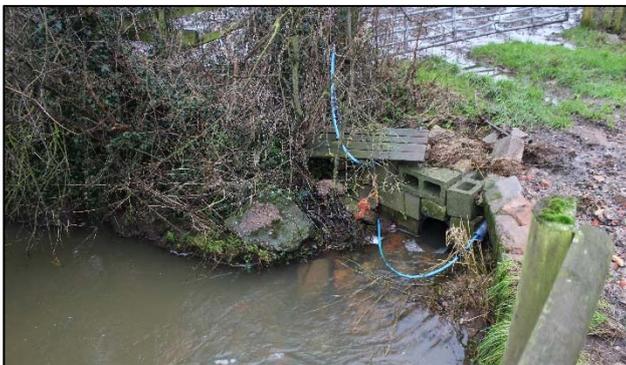
Before (January 2016)

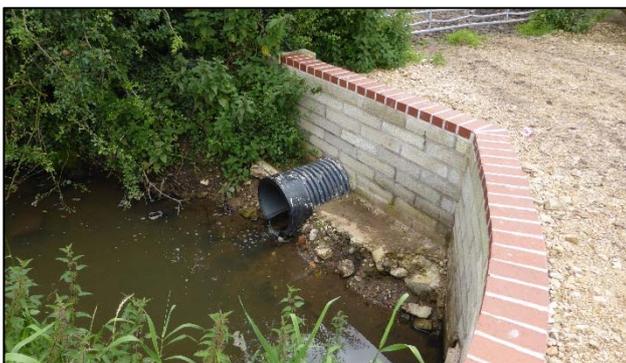
After (July 2016): Pipework and headwalls.
