CASE STUDY 5

IZAAK WALTON GOLF COURSE

FARMING FLOODPLAINS for the FUTURE

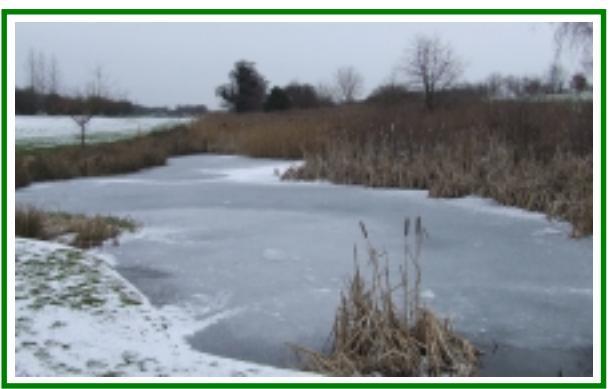
Existing on-line pond

- 4 The on-line ponds in the tributary stream have sufficient freeboard to allow storage of additional water. The outflows for the two largest ponds each comprise three 300mm diameter pipes. Under 'normal' flow conditions, the pre-existing pond water level is now maintained by a single pipe. The other two pipes have been altered, fitted with 90° bends (and on the downstream pond, where freeboard is greater, additional risers) such that once the capacity of the single pipe is exceeded, water is backed-up and stored in the pond upto the level of these other pipes, which then carry excess flow downstream. The storage capacity of both ponds has been enhanced with the construction of shallow bunds around their downstream ends. Depths of additional storage is 0.52m (upstream pond) and 0.8m (downstream pond), equating to volumes of 365m³ and 930m³ respectively.
