CASE STUDY 6

BELLFIELDS FARM

FARMING FLOODPLAINS for the FUTURE

Catchment	Penk (Church Eaton Brook)
Holding Type	Mixed livestock (sheep & cattle)
Existing Land Use	Species-poor, semi-improved grassland
Project Area	4.2ha [Total holding : 93ha]
Techniques	Flood storage ; small-scale habitat creation

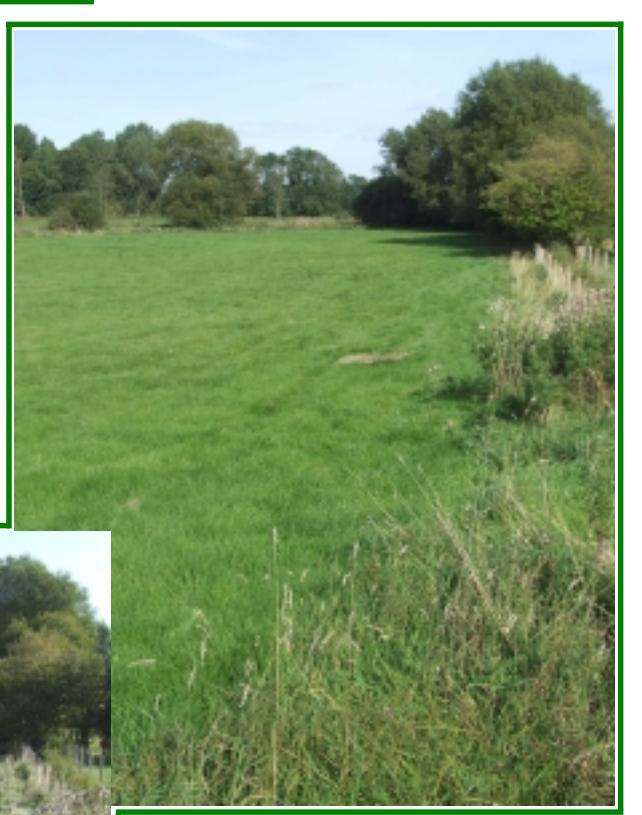
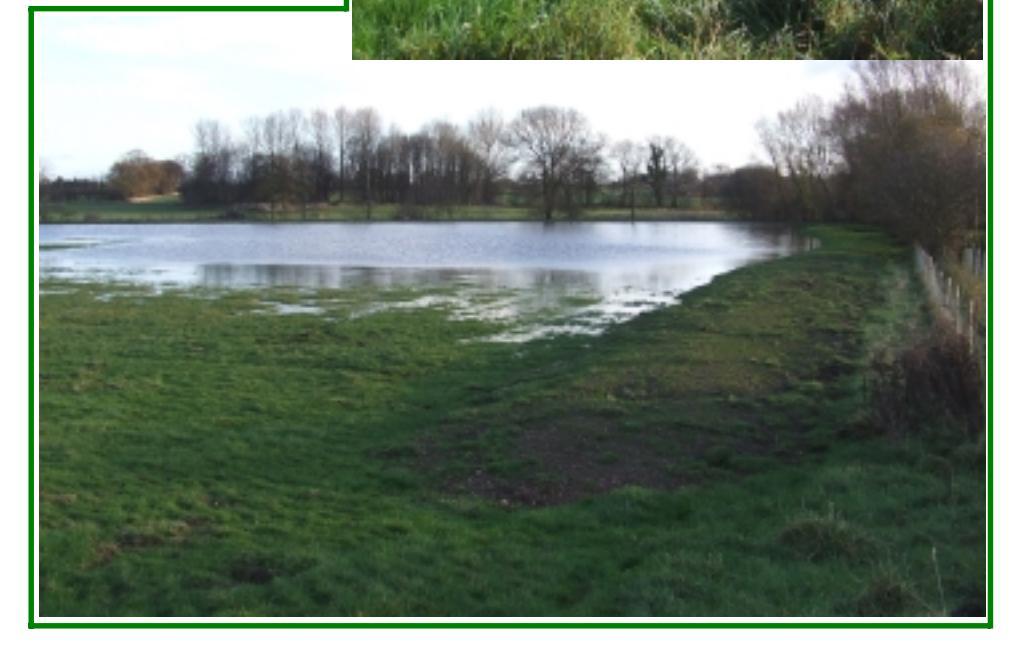
Field-edge bund before and after works, and during flood

- 1 The main element of the scheme is a 415 metre long embankment running parallel to the Church Eaton Brook and along the southern boundary of the field. This defines the extent of flood storage, with the latter part required to prevent any adverse impact on the neighbouring landowner. Tied into higher ground at either end, the earth bund averages 0.62 metres in height above existing ground level (increasing to a maximum of 0.97 metres where spanning existing low spots). The footprint of the bund averages 6.5 metres in order to generate shallow slopes suitable for maintenance with standard tractor-mounted machinery.

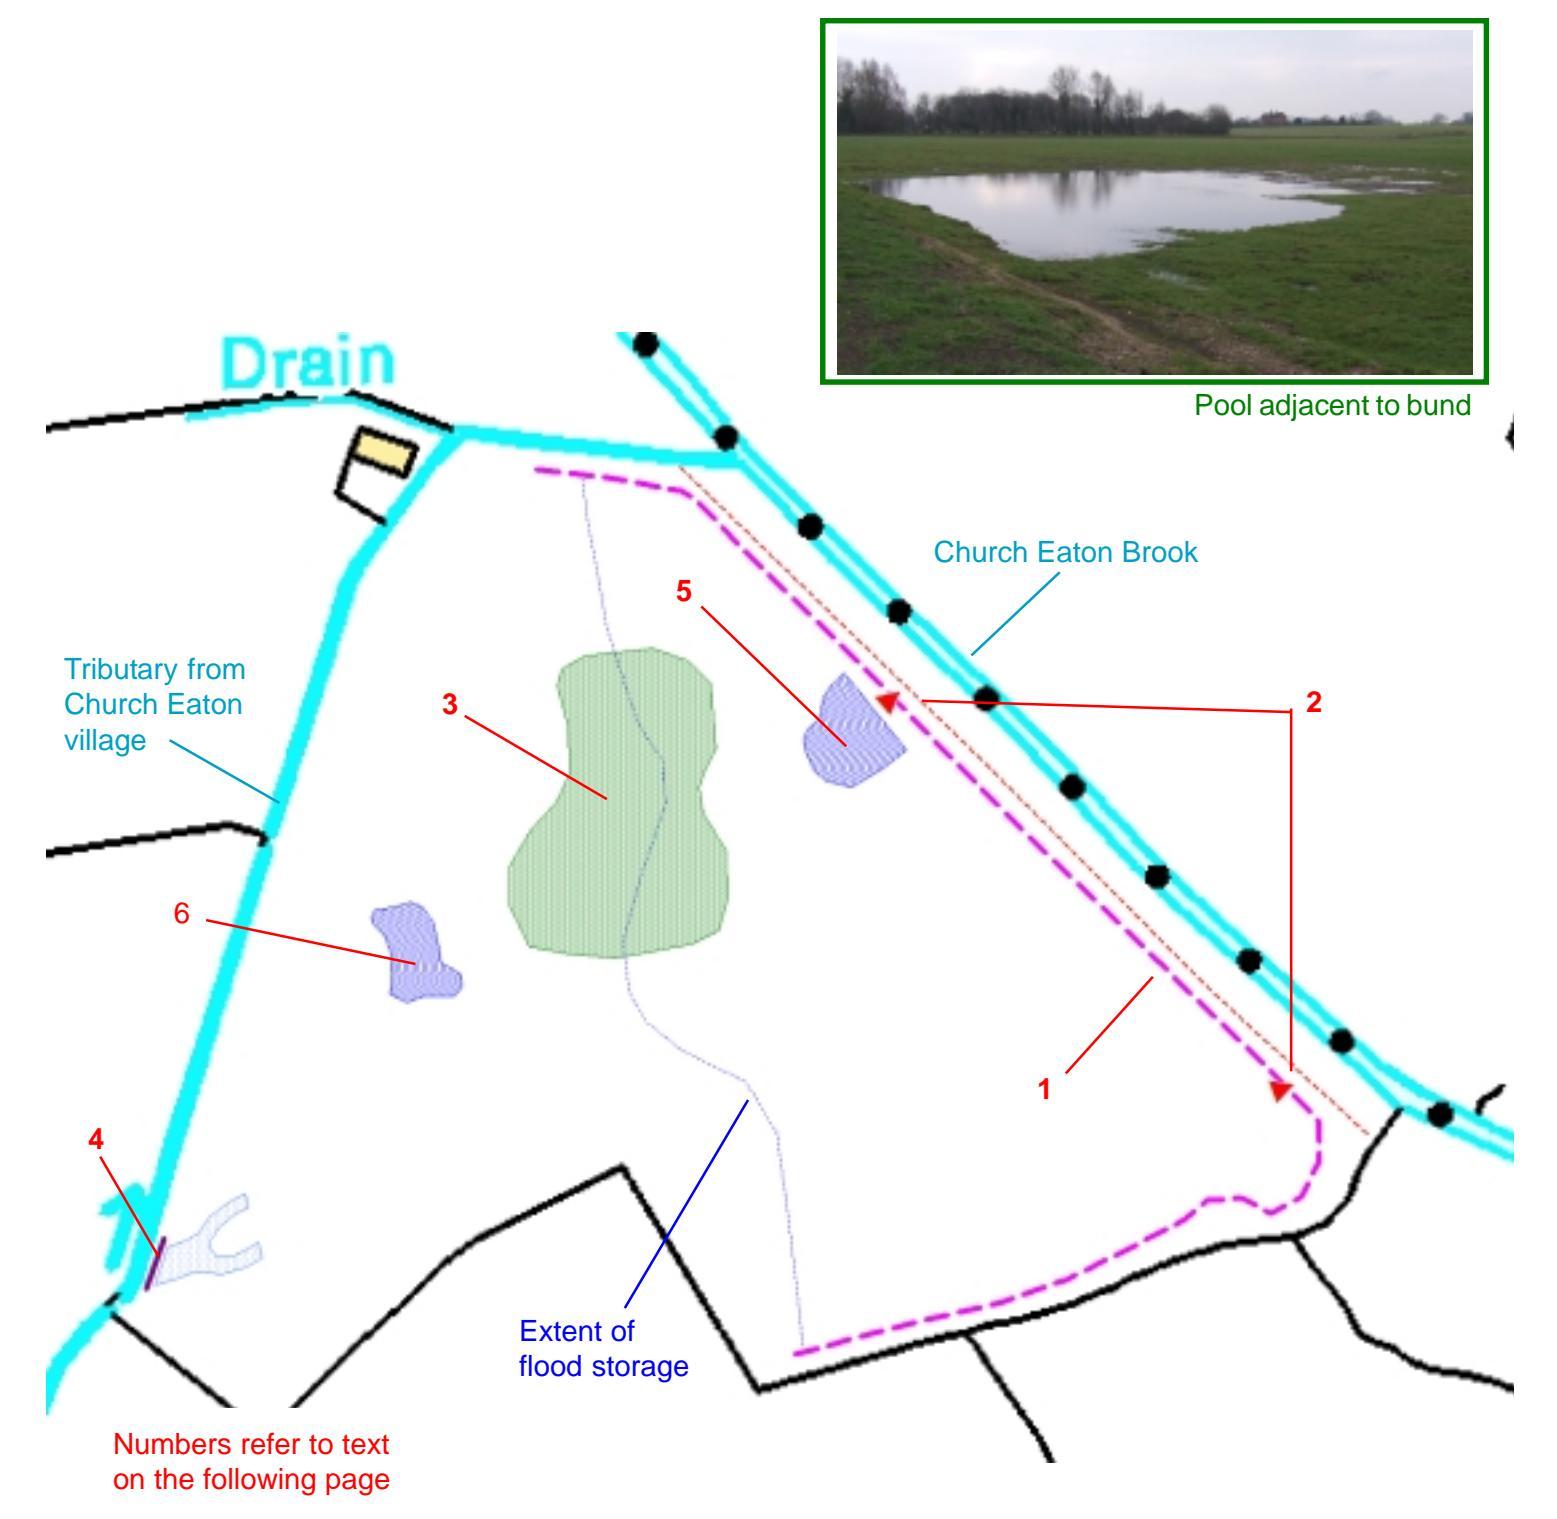
Utilising the existing topography of a field lying adjacent to the confluence of the two watercourses associated with the village of Church Eaton, a flood storage scheme was devised, incorporating minor habitat enhancements.

Church Eaton Brook is designated by Defra as 'main river'. Therefore in order to avoid the need to obtain Flood Defence Consent for the scheme, no part of the works has been allowed to fall within 8 metres of the top of the Brook bank (see dotted red line on map).

- 2 Outflow from the flood storage area is via two 150mm diameter pipes through the bund, outfalling to the Church Eaton Brook. Both are fitted with flap valves on the downstream end, to ensure that during flood conditions water cannot flow up the pipes from the Brook. Should the flood storage area fill, a low section in the eastern corner of the bund acts as an overflow.

- 3 All material for construction of the bund was sourced from site. This was primarily generated through the lowering of areas of high ground, targeted so as to also increase the storage capacity of the scheme. As the field has returned to agricultural management, all topsoil was removed (including from the line of the bund) and replaced (with the farm re-seeding as appropriate).

- 4 Water feeds into the flood storage area via a spillway in the right bank of the tributary watercourse at the upstream end of the field, created by accentuating and extending an existing low spot in the bank. Minor reprofiling within the field ensures that any water coming over the spillway effectively flows into the flood storage area.

- 5 Taking advantage of an existing low spot, one of the outfall pipes has been set above ground level, such that inside the bund water is retained to create a small pool.

- 6 A second semi-permanent pool has been created through accentuation of an existing low spot in the field.

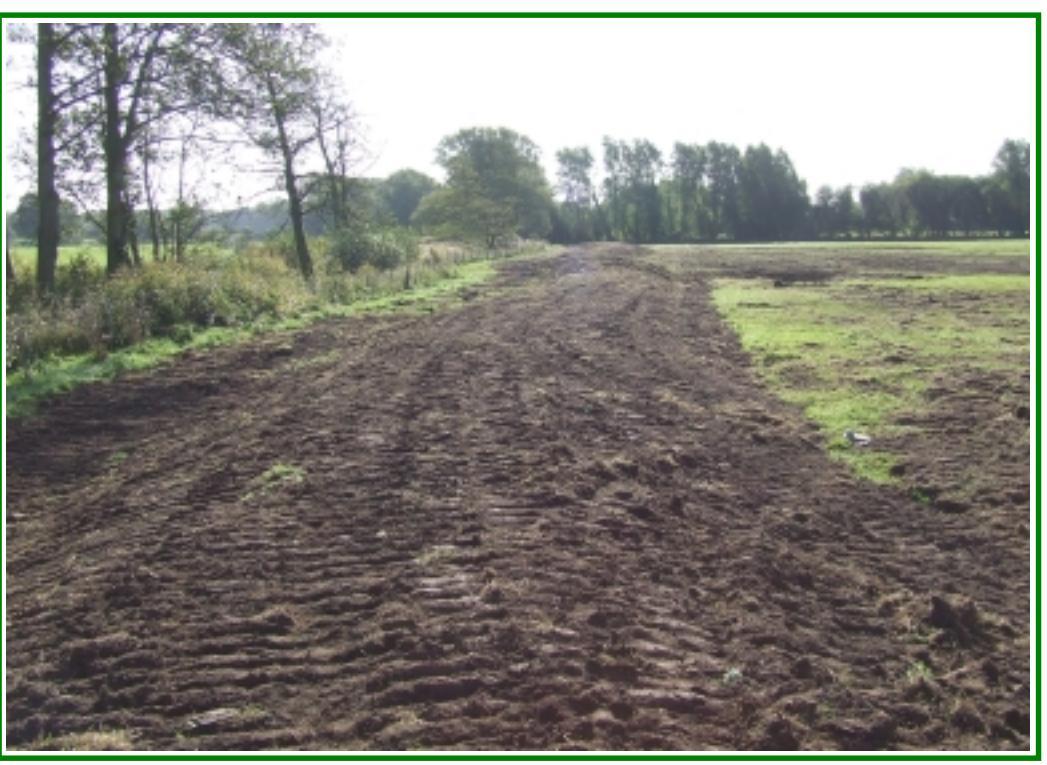
Bund adjacent to Church Eaton Brook

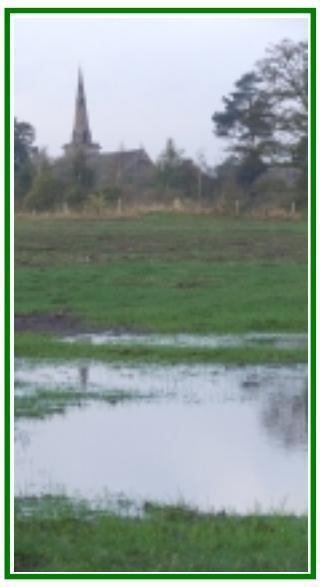
Pool with chuch beyond
